IMPACT OF EXPANDABLE SOIL ON FOUNDATION OF BUILDING STRUCTURES:
THE CASE OF CONDOMINIUM HOUSES IN ADDIS ABABA

M.Sc. Thesis

Dejenie Abere

June, 2017

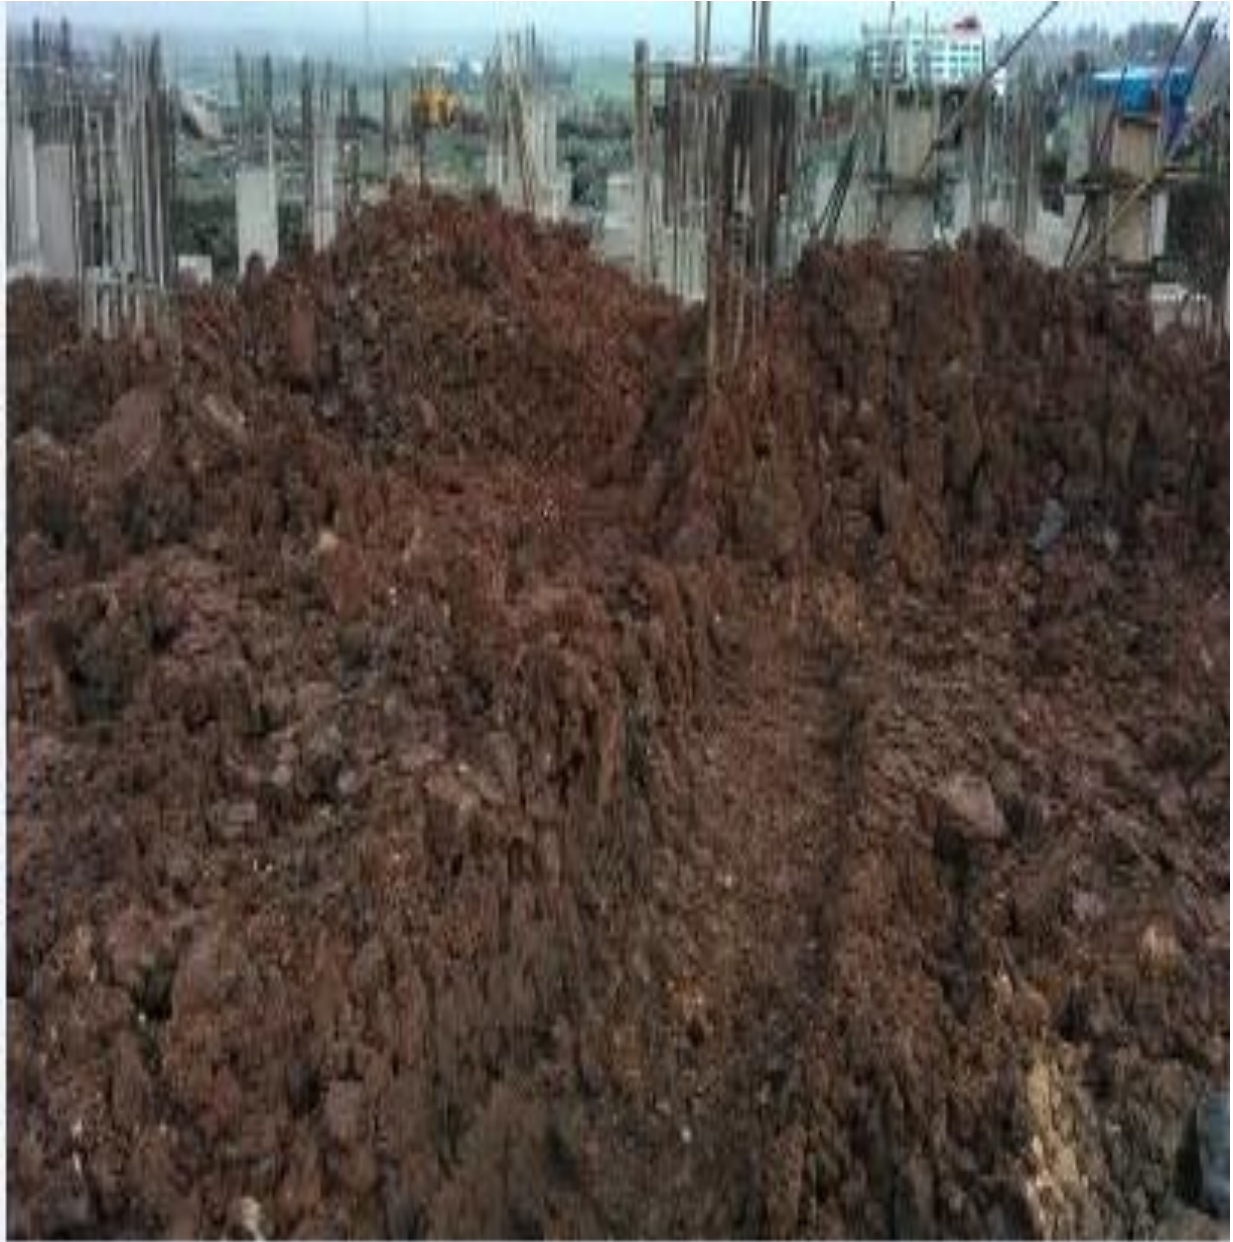
Appendix 10: Bole Arabsa 3: Excavating pile of soil for backfill and the practice is applicable for the purpose of cost cutting

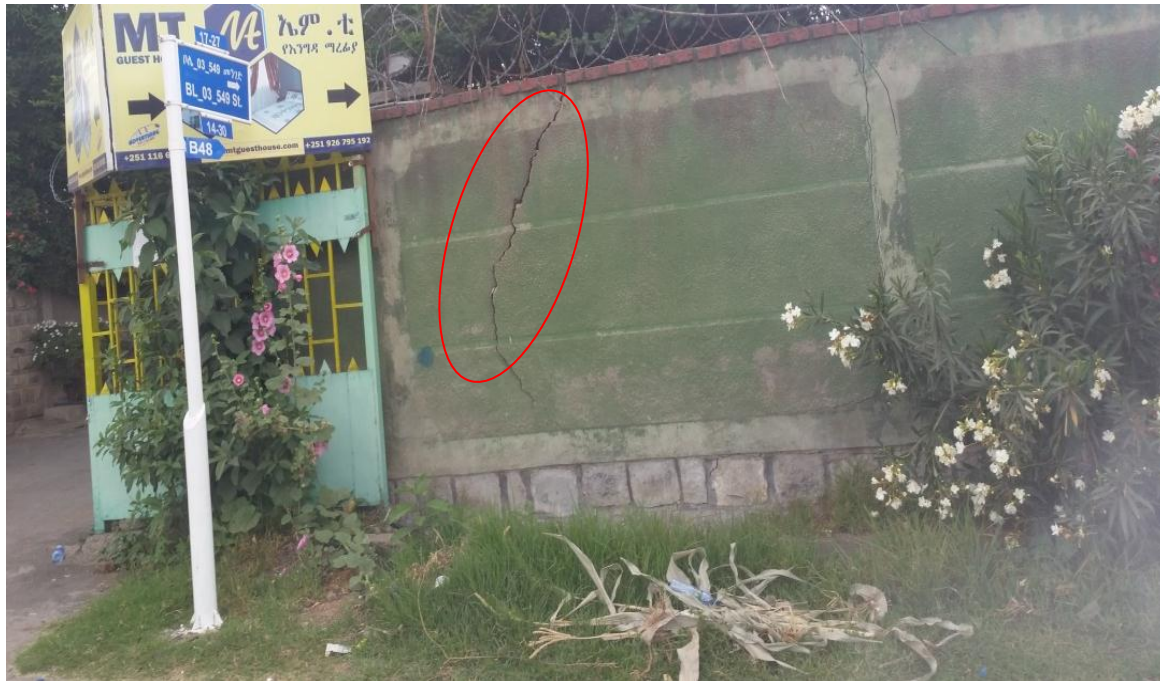
Appendix 13: Severe diagonal fence wall cracking in Bole area due to garden watering

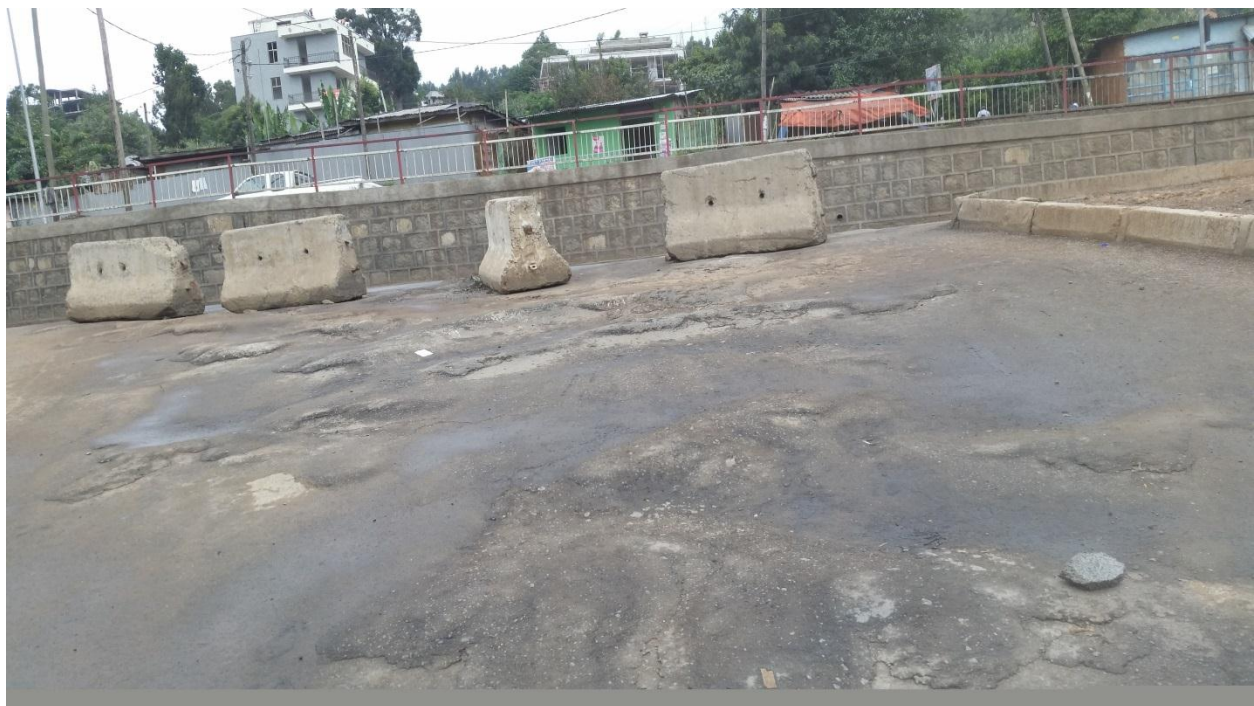
Appendix 14: Lamberet-Transport route damage due to expansive soil and Compaction Problem

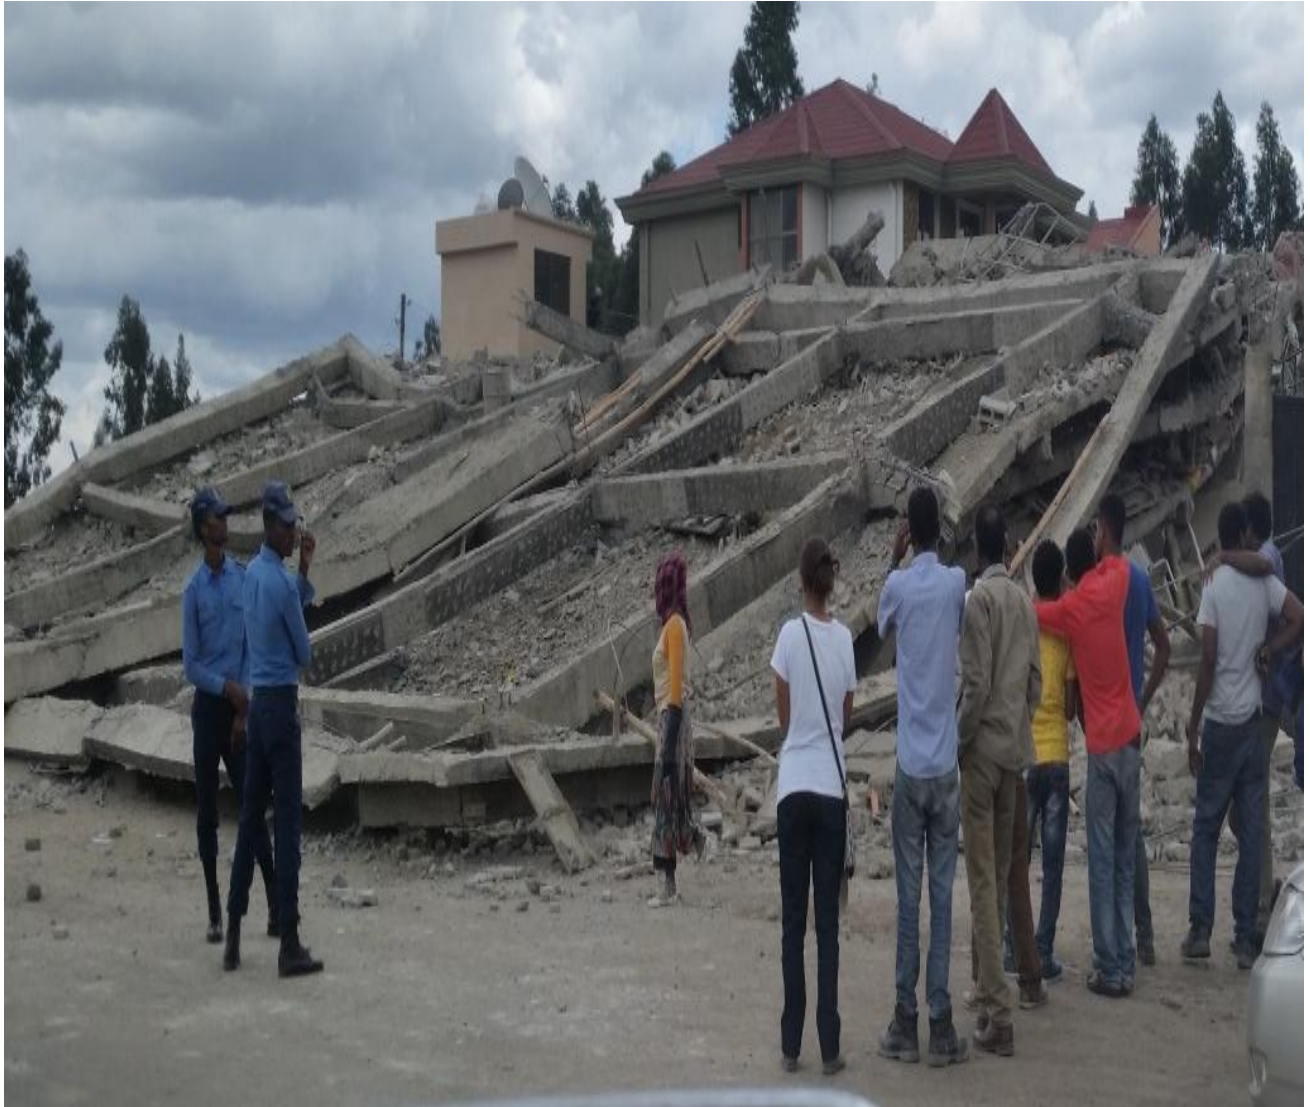
Appendix 15:Semit G+4: Failure of building which was being constructed on expansive soil

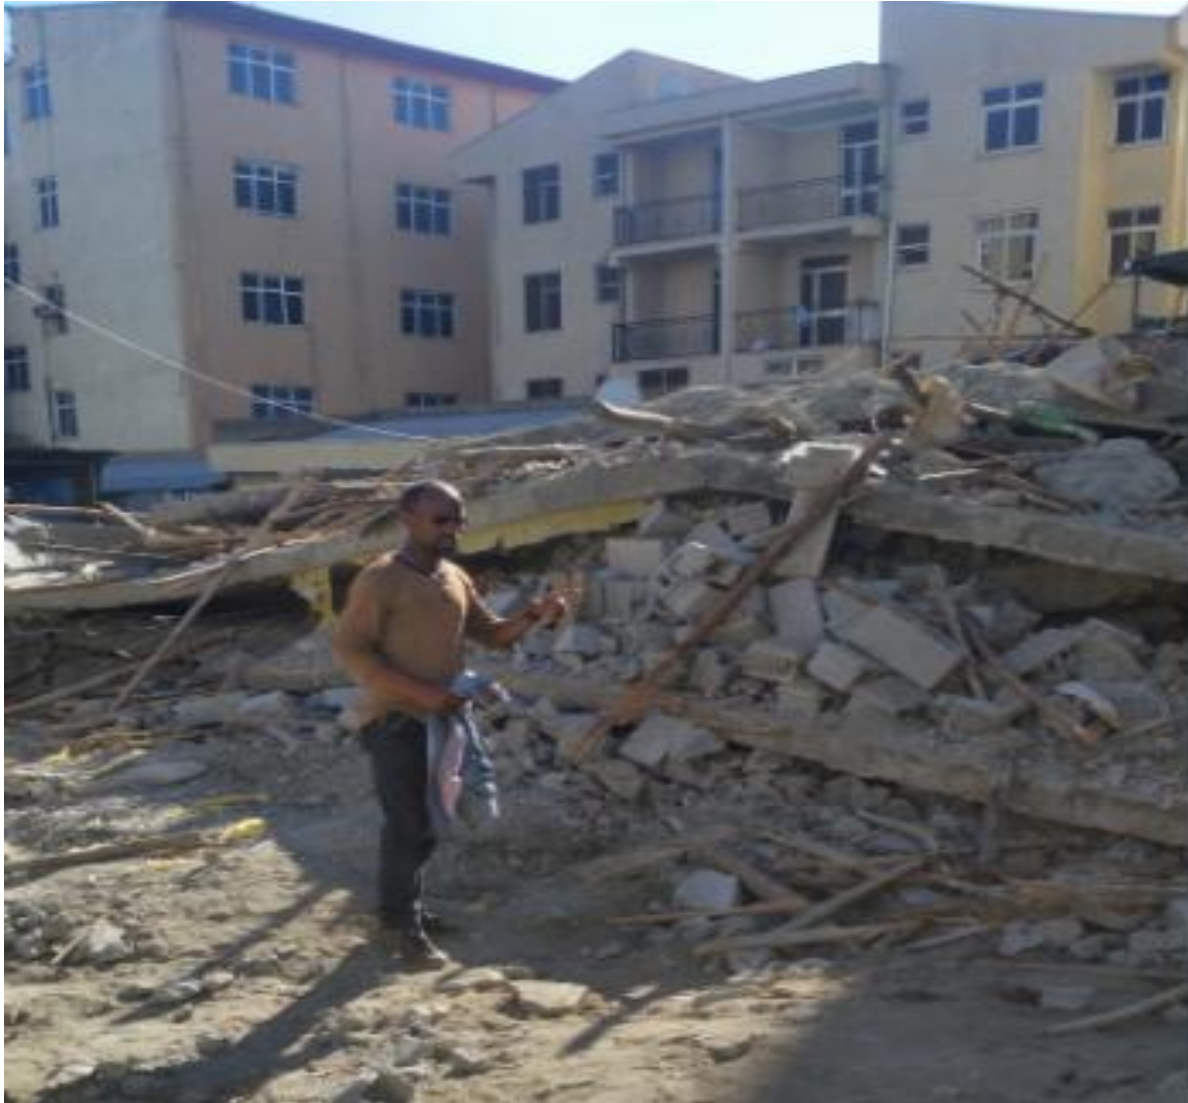
Appendix 16: Semit G+4: Collapsed of unfinished building

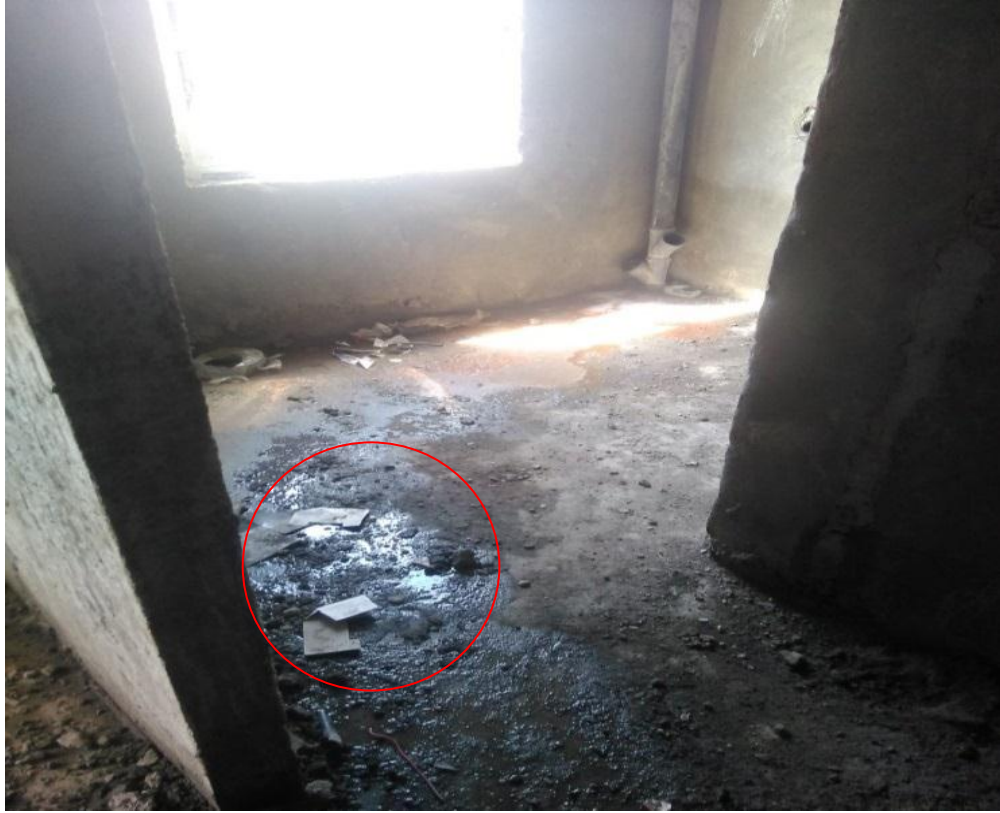
Appendix 17: Yeka Ayat No.2 Block 304 HNo.1 Sewerage Pipe Broken and the whole sewerage drops in to the ground floors.Broken sewerage pipe may be occurred due to soil movement.
